# Manhole Inspection Summary

Manhole # S19GG\_016MH

Insp Date: **6/13/07 12:27 PM**

**Location** Address: **1522 PAYSON-PULASKI**

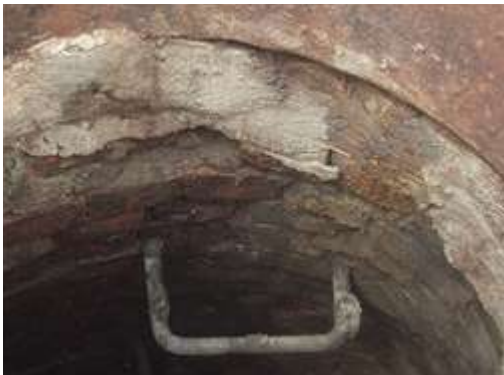
Defect 1

Infiltration: ☐ None ☐ Joint ☐ Cracks ☐ Mortar ☐ Roots ☒ **Wall**

Condition: ☐ Sound ☐ Cracked ☐ Root Intrusion ☐ Loose Brick ☒ **Deteriorated**

DETERIORATION OF CORBEL AND  
INFILTRATION OF CHIMNEY

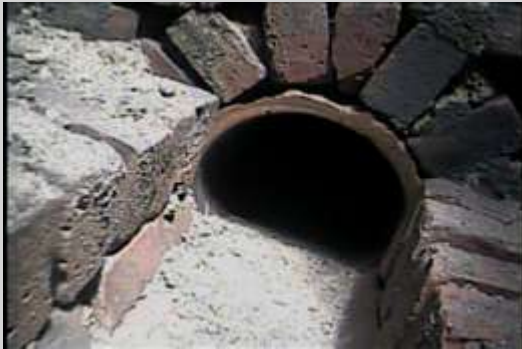
12 O'Clock Outflow

Pipe Height: **7.2** (in.) Rod and Bar (Angled)  
Pipe Material: **Clay** ☐ Pipe Lined  
Invert Depth: **6.31** (ft.) Flow Characteristics: **None**  
Deposits: ☐ None ☐ Mud ☐ Sludge ☒ **Debris** ☐ Grease  
Silt Depth: **2** (in.) Deposits Extent: **Light**  
Infiltration: **None** Pipe Seal Cond: **Broken**

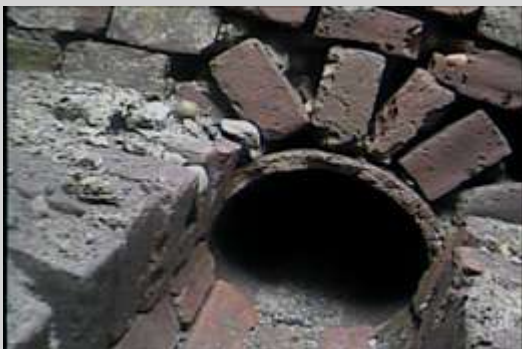
6 O'Clock Inflow

DETERIORATION OF BARREL ABOVE PIPE

Pipe Height: **8.4** (in.) Rod and Bar (Angled)  
Pipe Material: **Clay** ☐ Pipe Lined  
Invert Depth: **6.23** (ft.) Flow Characteristics: **None**  
Deposits: ☐ None ☐ Mud ☐ Sludge ☒ **Debris** ☐ Grease  
Silt Depth: **1** (in.) Deposits Extent: **Light**  
Infiltration: **None** Pipe Seal Cond: **Broken**
